# Neglected Achilles Tendon Repair

A case study by Peter G. Mangone, MD Blue Ridge Bone and Joint, Asheville, NC

## CASE STUDY: NEGLECTED ACHILLES TENDON REPAIR WITH ORTHADAPT® BIOIMPLANT ONLY REINFORCEMENT

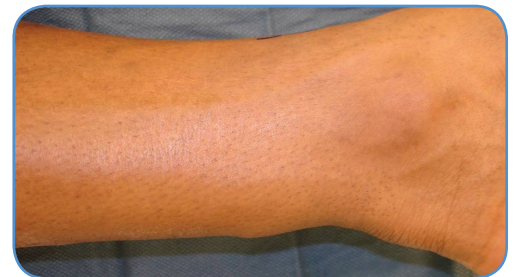
Figure 1. Initial injury

The patient, a generally healthy male with a history of nicotine use was seen for a left Achilles tendon injury. Two months prior, he recalled feeling a "pop" while playing sports. He experienced significant pain, was unable to push off, and experienced decreasing function over time. Medical treatment was not sought initially. When finally seen by a doctor, he was placed in a CAM boot. The authoring physician subsequently diagnosed him with a left Achilles tendon rupture (Figure 1). The patient had a 5 to 7 cm palpable gap near the watershed region of the Achilles tendon. He had no plantar flexion with the Thompson test but was neurovascularly intact. The patient opted for surgical repair.

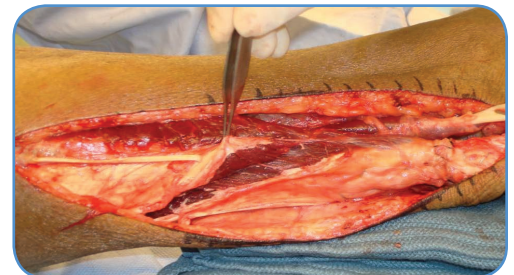
Figure 2. Achilles tendon reapproximation via V-Y advancement

The patient was placed under general anesthesia in the supine position, and a tourniquet was used. The reconstruction consisted of a left Achilles tendon repair with lengthening of the gastrocnemius, Flexor Hallucis Longus (FHL) transfer, and application of the OrthADAPT® Bioimplant. An Achilles tendon lengthening via V-Y advancement was performed for adequate reapproximation of the 6 cm gap and reconstruction. (Figure 2)

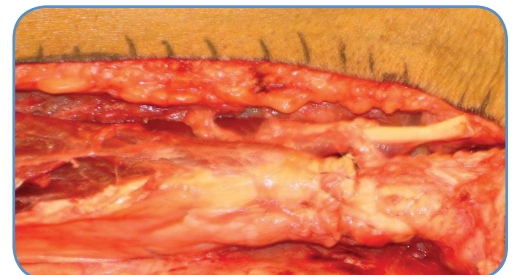
Figure 3. FHL transfer in place

Next, the FHL was identified and traced distally. The neurovascular bundle was identified and protected. The FHL was then pulled out of the posteromedial aspect and released. The FHL was placed into the calcaneus at the central posterior aspect and secured in the bone tunnel with a tenodesis screw (Figure 3).

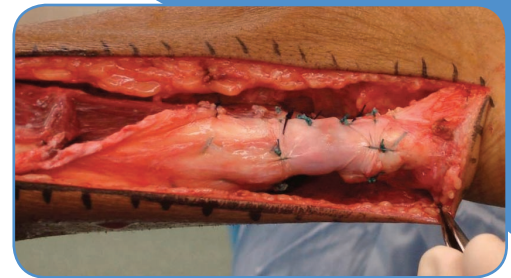
Figure 4. Final repair with OrthADAPT® Bioimplant Onlay Augmentation

Finally, the OrthADAPT® Bioimplant was used as a posterior onlay to reinforce and augment the repair. The OrthADAPT® Bioimplant was sutured under tension using 2-0 FiberWire®. The OrthADAPT® Bioimplant covered approximately 80% of the repair site, while keeping the medial anterior aspect of the repair open (Figure 4). Care was taken to slightly over-tighten the repair so the Achilles would not be too far lengthened. The FHL muscle belly was sutured to the tendon to provide direct blood supply to the repair. The wound was thoroughly irrigated with antibiotic solution. The incision was closed in layers, ensuring that the paratenon was closed first, followed by the subcutaneous tissue and then the skin. The patient was placed in a short leg splint with the ankle in gravity equinus.
